Galvanizing Processes

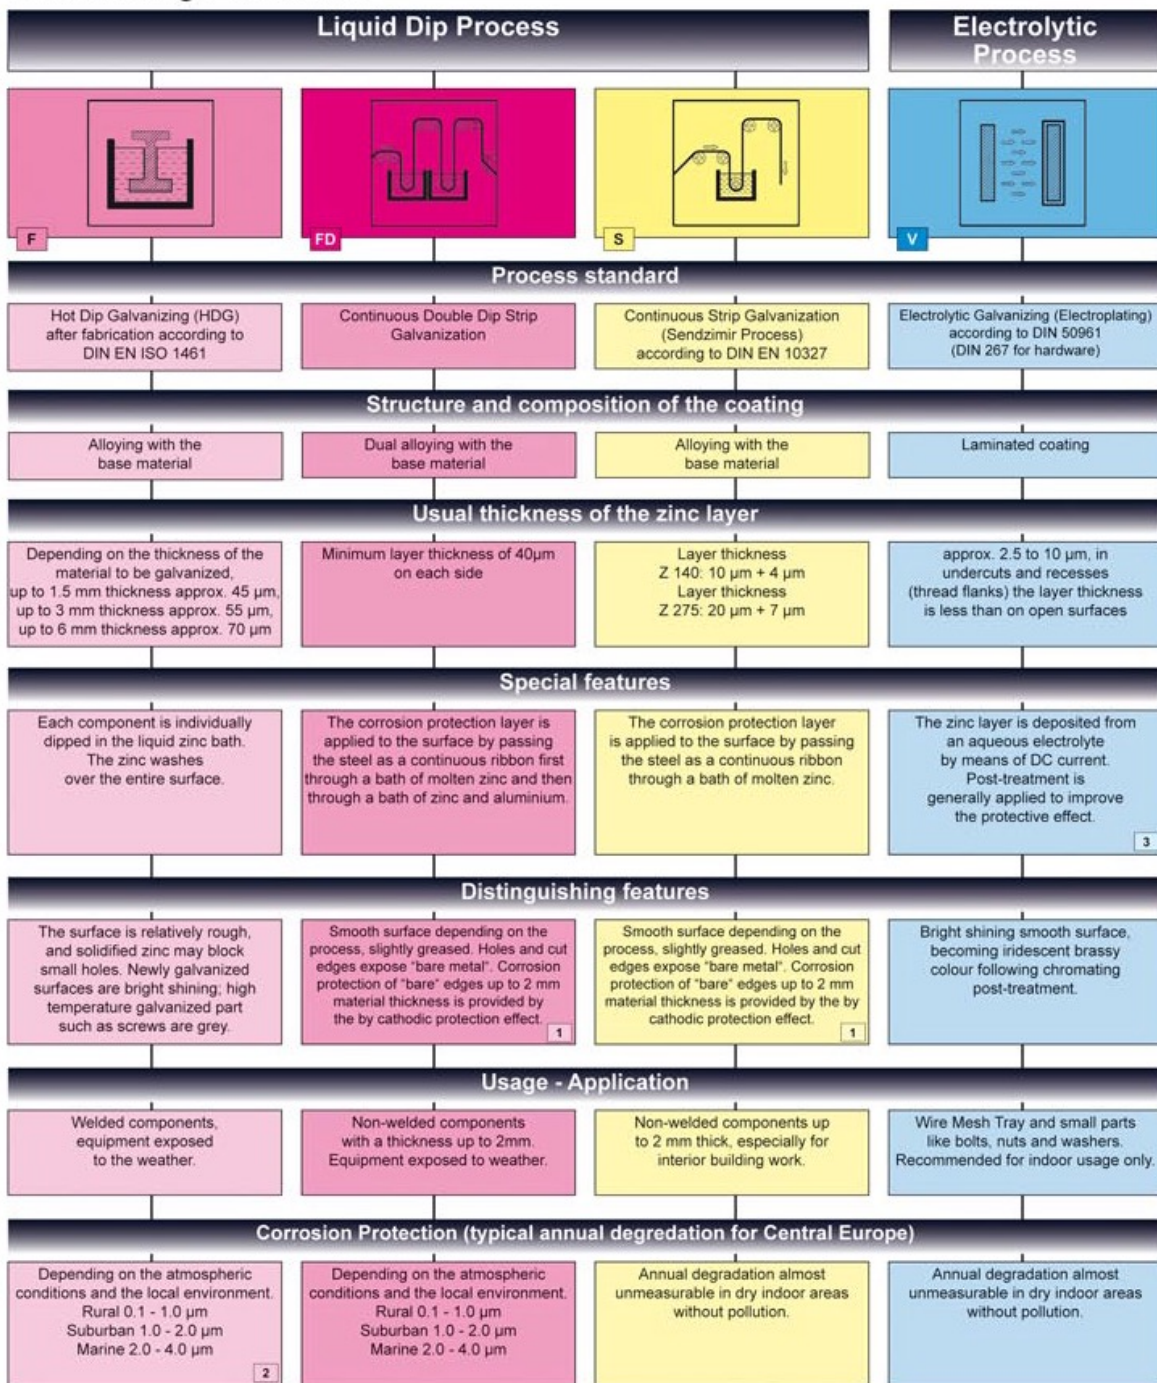
1 Components over 2 mm in material thickness are hot dip galvanized at NIEDAX

2 Local environmental conditions would be for instance the direct corrosive effect of a chimney with CO₂ flue gases.

3 Chromating process is ROHS compliant.
